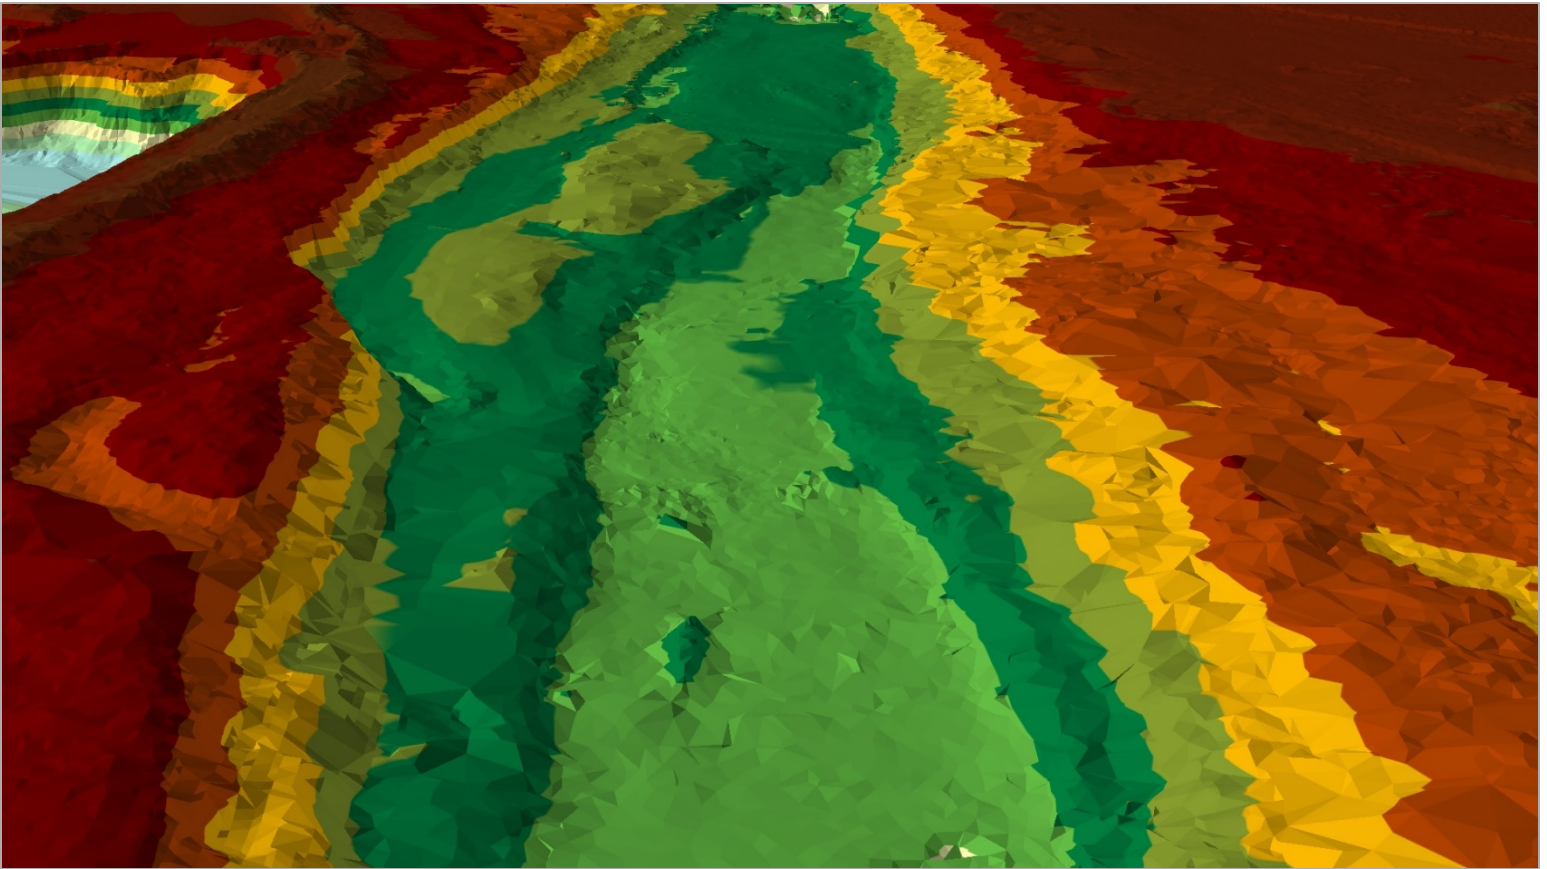
**Figure 5. Three dimensional image from ArcScene detailing a sample of the partially processed upstream Study site surface.**

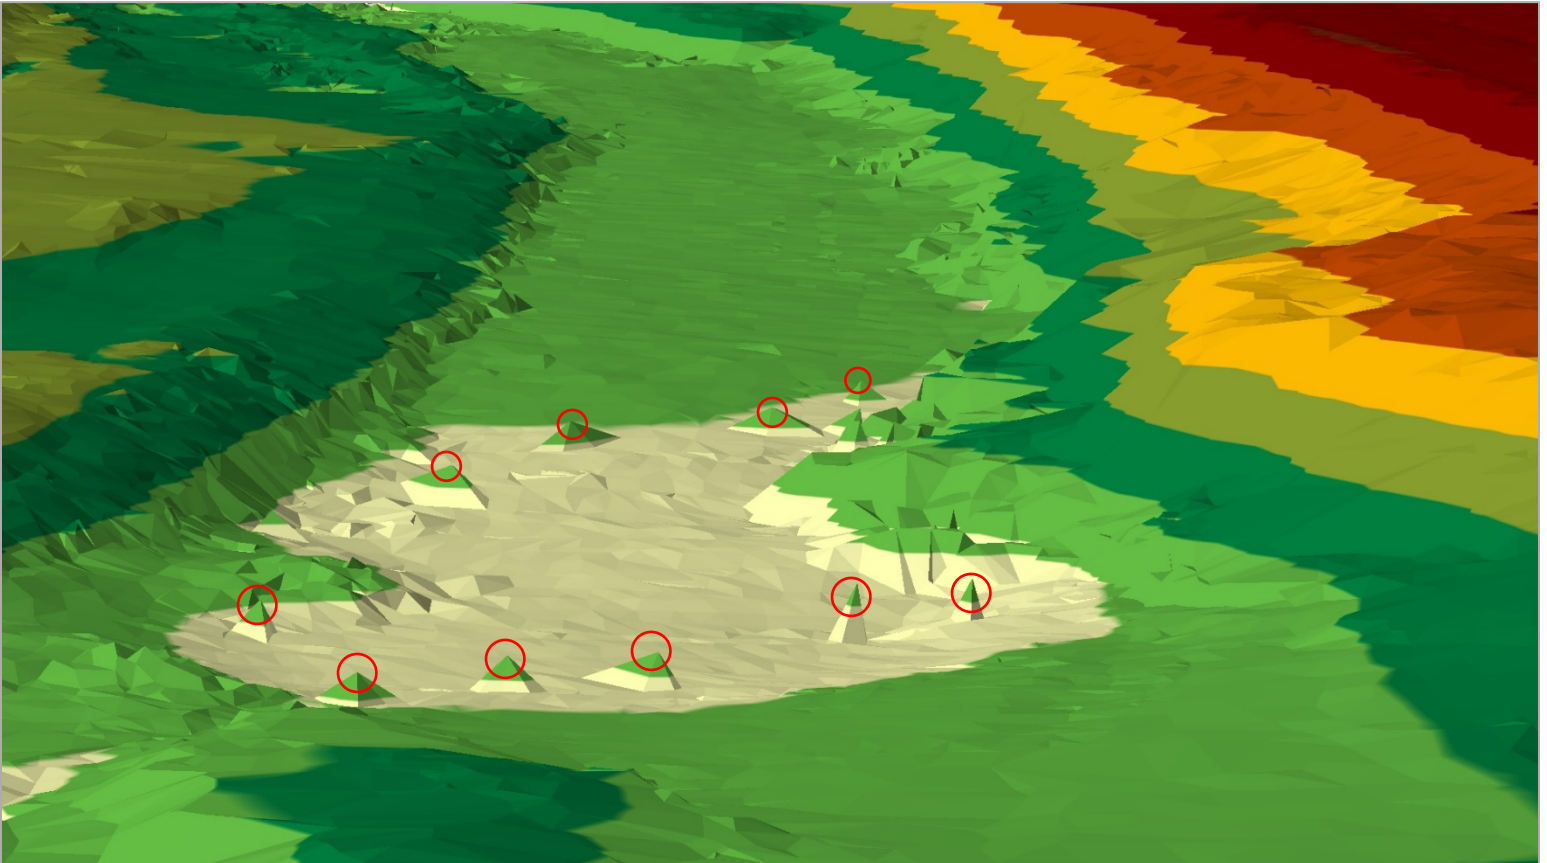
**Figure 6. Three dimensional image from ArcScene detailing a sample of the partially processed upstream Study site surface. Examples of potentially erroneous bathymetric sonar returns are identified in in red.**
